April 7, 2004

RE: Massachusetts Water Resources Authority  
NPDES Permit Number MA 0103284  
Deer Island Treatment Plant Power Failure and Bypass, April 3, 2004

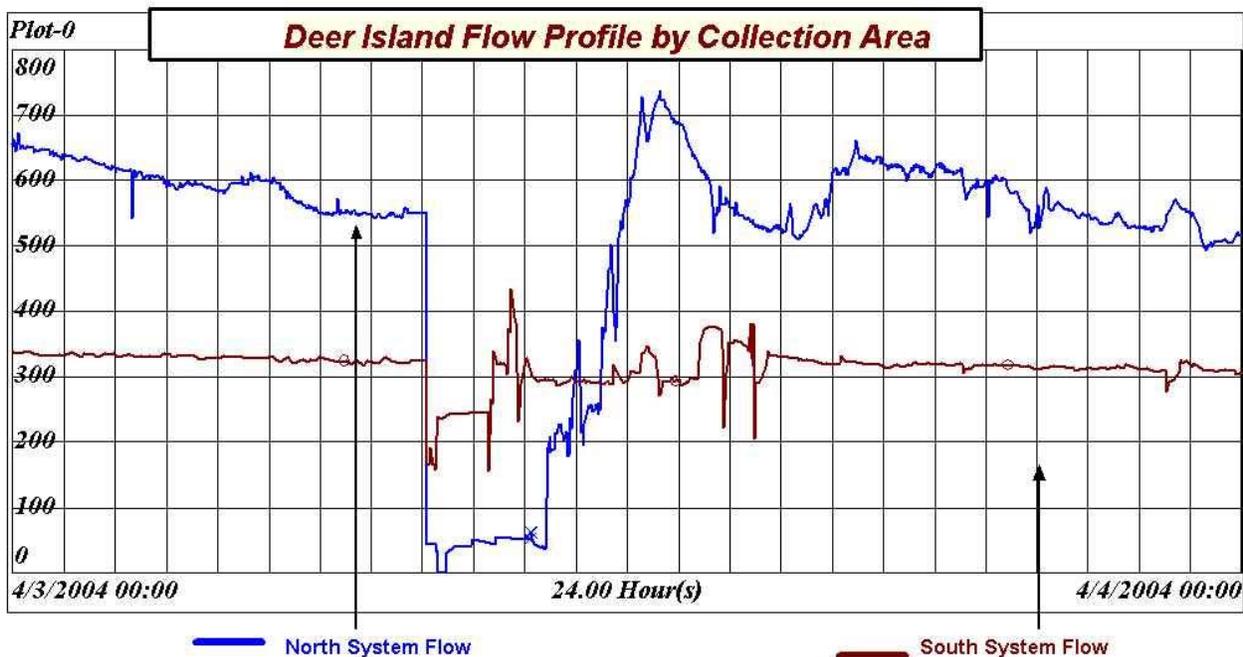
At the time of the NStar power failure, DITP was operating some pumps from the NMPS, SSPS, and WTF on the A bus and some on the B bus. The power failure affected the B bus, causing the loss of three of five active pumps at SSPS, and one of two pumps at the WTF. However, at NMPS all of the pumps, including pumps on both the A bus and B bus, shut down.

Power was restored by MWRA staff within minutes. MWRA was able to immediately bring on an additional pump at WTF, and began the process of increasing pumping at SSPS. However, none of the pumps at NMPS could be restarted. Upon investigation, staff discovered that a control panel that provides status updates to the NMPS pumps was not energized. The control panel signals “permissives” to each of the NMPS pumps to start the units ensuring that the pumps start safely. Power is supplied to the control panel through an Uninterruptible Power Supply (UPS). Staff found that the UPS had failed during the outage period, and that the automatic bypass for the UPS unit also failed. Staff manually bypassed the UPS and reestablished power to the control panel at 10:15 a.m. NMPS pumps were then systematically brought back on line. North Main pumping was fully restored by 12:15 p.m.

The figure below shows the flow to DITP from the North and South Systems for the period surrounding the power and pumping failure.
