MASSACHUSETTS WATER RESOURCES AUTHORITY

October 20, 2005

RE: Massachusetts Water Resources Authority
NPDES Permit Number MA 0103284
Wet Weather and Deer Island Treatment Plant Power Failure and Bypasses, October 15,
2005

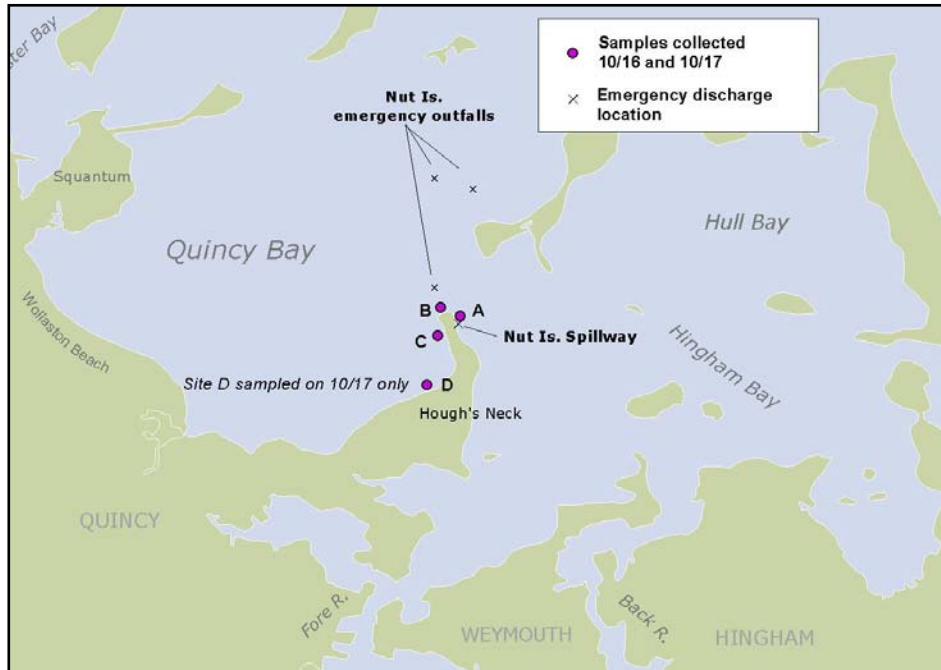
Results of Nut Island monitoring, October 16 – 17, 2005.

MWRA staff sampled the shoreline of Nut Island for bacteria on October 16 and 17. Sampling locations and bacteria data are shown below. Bacteria counts were slightly elevated the day after the discharge, and within water quality standards by Monday.

Site	Date/Time collected	Colonies/100 ml	
		<i>Enterococcus</i>	<i>E. coli</i>
A	10/16/2005 13:20	155	195
B	10/16/2005 13:26	55	70
C	10/16/2005 13:38	300	275
A	10/17/2005 9:58	5	25
B	10/17/2005 10:04	10	35
C	10/17/2005 10:13	10	50
D	10/17/2005 11:41	25	85
