## Proposed Public Use & Maintenance Plan Pine Tree Preserve

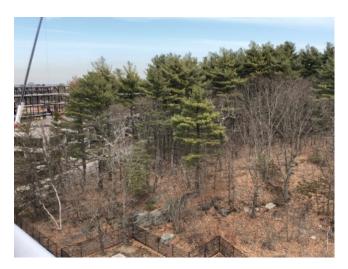
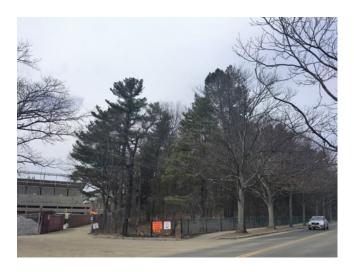
### **Existing Conditions**

- 38% in good condition
- 62% fair, poor
- Downed trees, invasive species, deadwood
- Many mature quality trees
- Chain link & iron fences on all sides

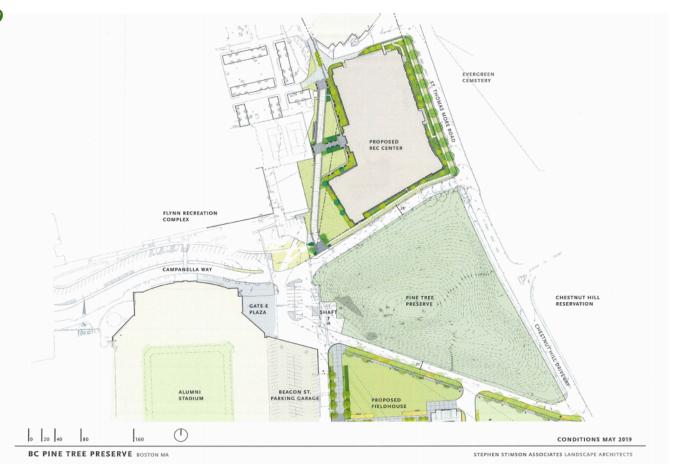
#### **Proposed Site Plan**

- Single looped accessible path
- Two improved entry plazas with benches, trash & recycle receptacles
- Removal of fence along existing BC exit and Thomas More Drive to provide public access
- "Greening" of existing Campanella Way

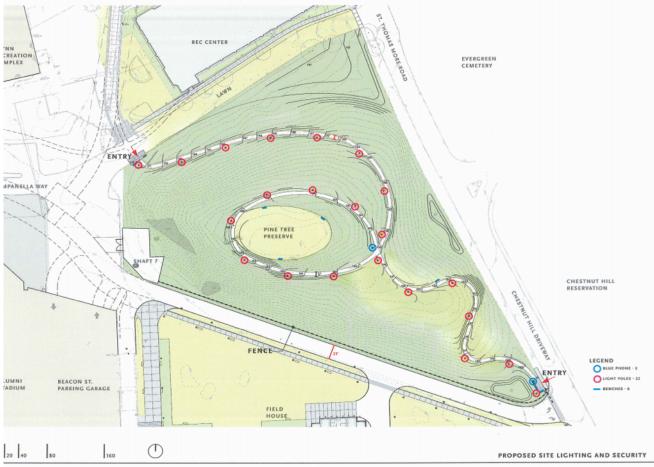
# Proposed Site Lighting & Security

- LED pole lights spaced approximately every 65' along pedestrian path
- Installation of emergency blue light phones
